**LEVEL** 12  
B.S.  
**THE PERFORMANCE OF  
SELECTED MARINE  
COATINGS  
EXPOSED TO HIGH  
VELOCITY SEAWATER**

By G. A. GEHRING, JR.  
Prepared for OFFICE of NAVAL RESEARCH

March 1979

OCEAN CITY RESEARCH CORP.

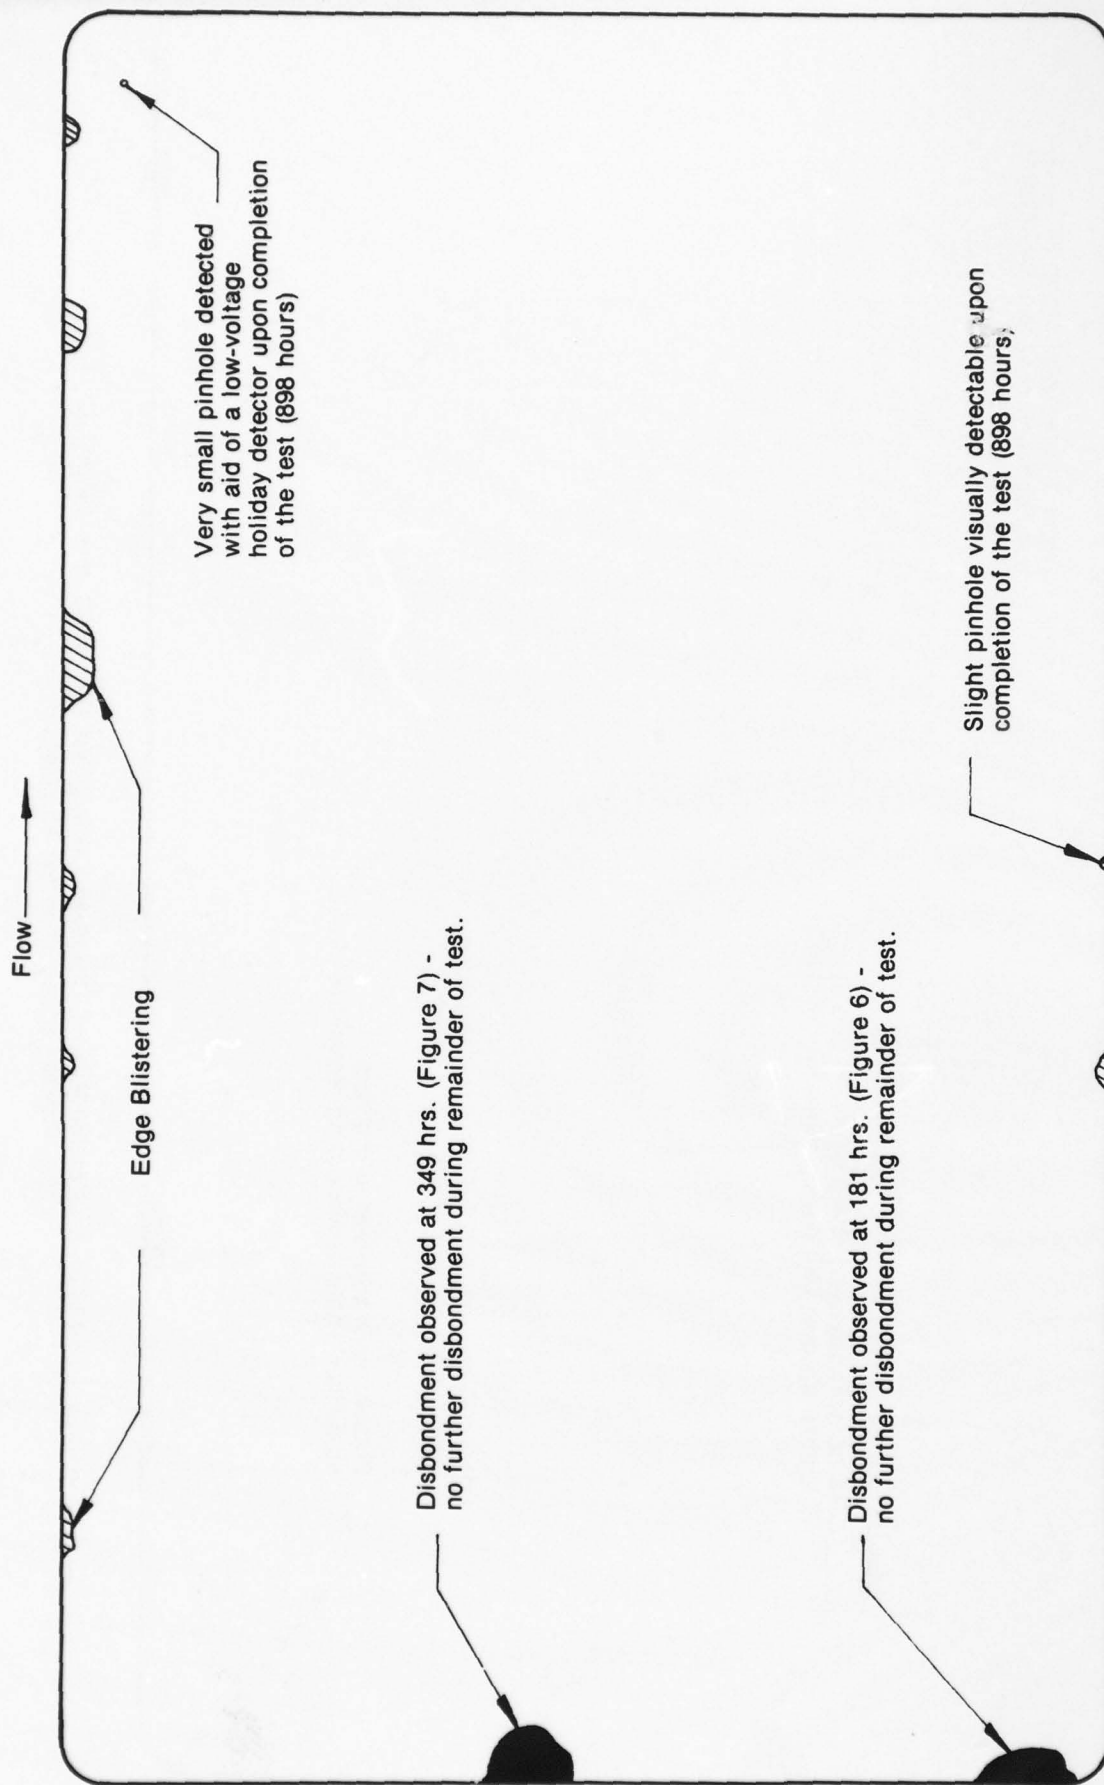
Two panels were exposed of this coating system. Figures 4 and 5 characterize the deterioration observed on the test panels as it developed throughout the test run. Figures 6 thru 10 are actual photographs of the observed coating deterioration.

**Figure 4 - Coating Failure Observed During Test Run at 30 m/s - Panel #1;  
MIL-P-24441 Epoxy (Approx. to Scale)**

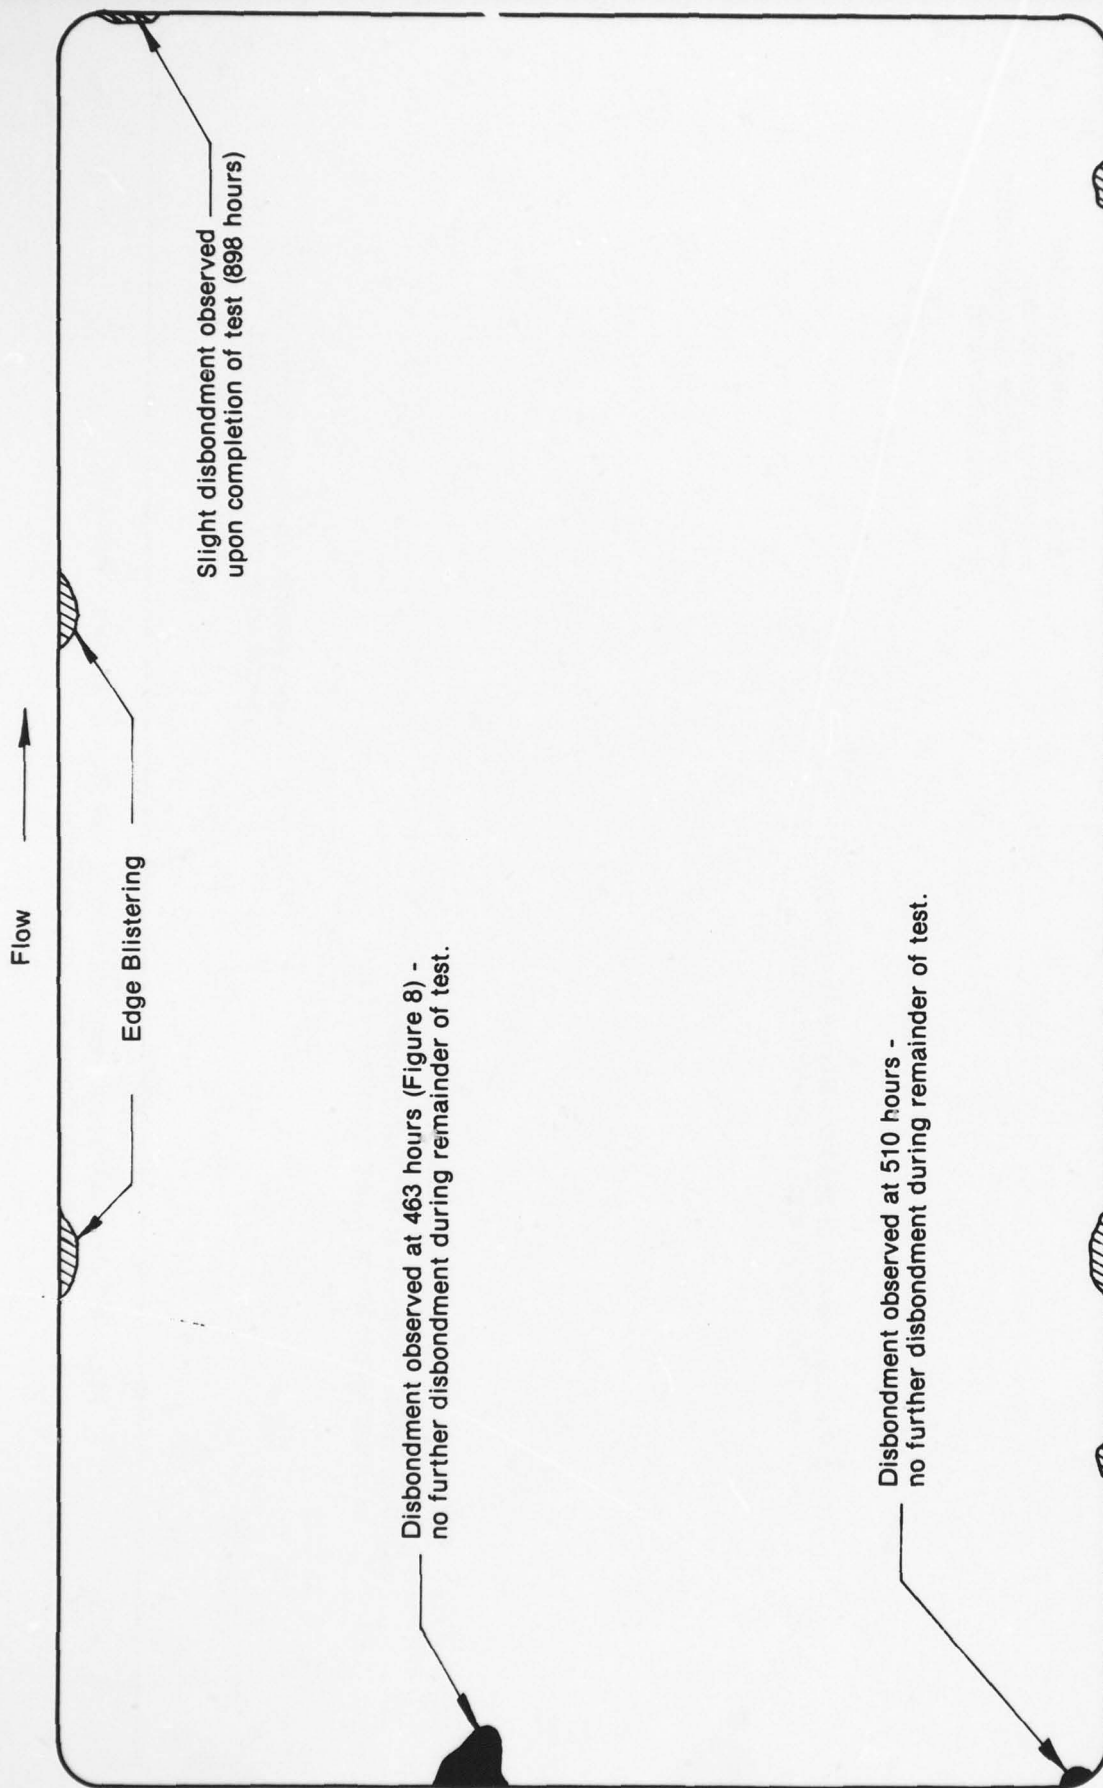
Figure 5 - Coating Failure Observed During Test Run at 30 m/s - Panel #2;  
MIL-P-24441 Epoxy (Approx. To Scale)

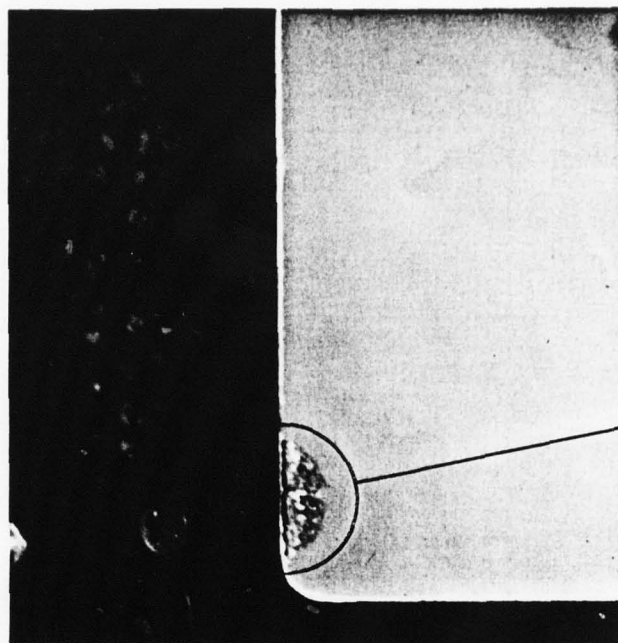
Figure 6a

The first sign of coating deterioration was observed on Panel #1 (upstream panel) at 181 hours into test (Figure 6). Coating disbonded over about a 2 cm<sup>2</sup> area on the leading edge. This coating holiday remained approximately the same size over the remainder of the exposure. Corrosion of the exposed steel substrate occurred quite rapidly and at the end of the exposure a pit of .300 mm was measured (Figure 6a). The apparent stability of the coating about the initial holiday was surprising. It had been anticipated that, in the event of such a failure at this velocity, coating disbondment would proceed rapidly from this point.

**Figure 6 - Coating Disbondment Observed at 181 Hours at 30 m/s - Panel #1;  
MIL-P-24441 Epoxy.**

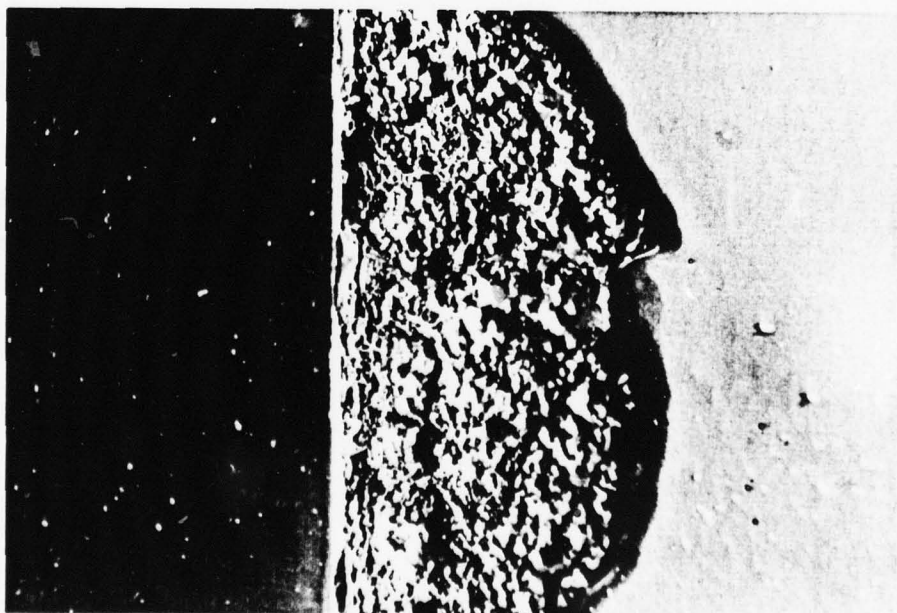
**Figure 6a - Close-Up of Coating Holiday After 898 Hours - Panel #1.**

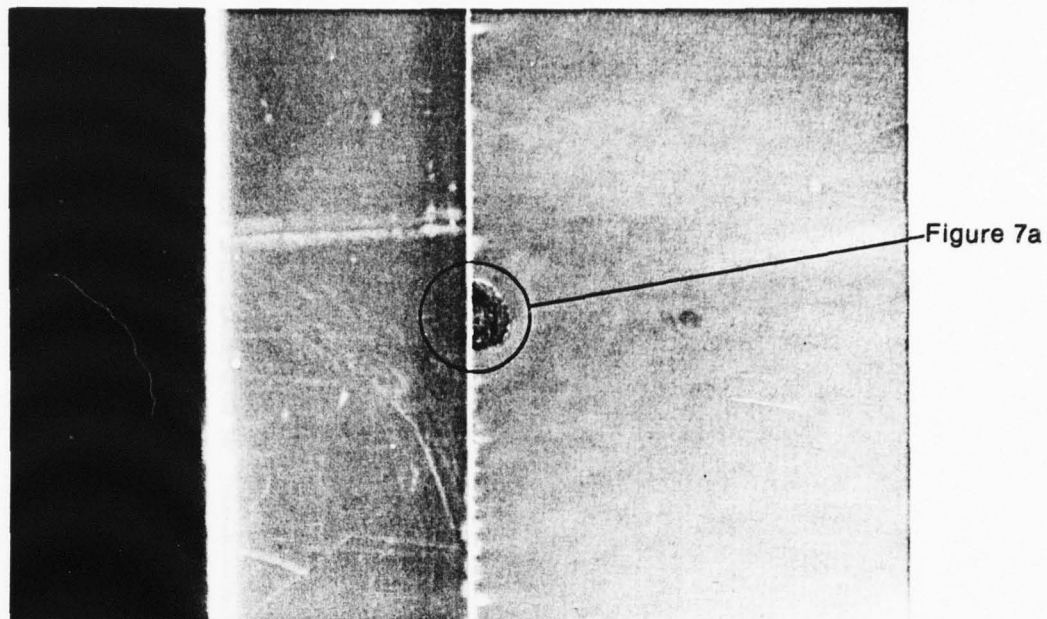
The next observed failure occurred on the same panel at  $\approx$  349 hours into test. Again, the failure was in the form of disbondment initiating at the leading edge (Figure 7). The holiday remained stable in size over the remainder of the test period.

**Figure 7 - Coating Disbondment Observed At 349 Hours at 30 m/s - Panel #1;  
MIL-P-24441 Epoxy**

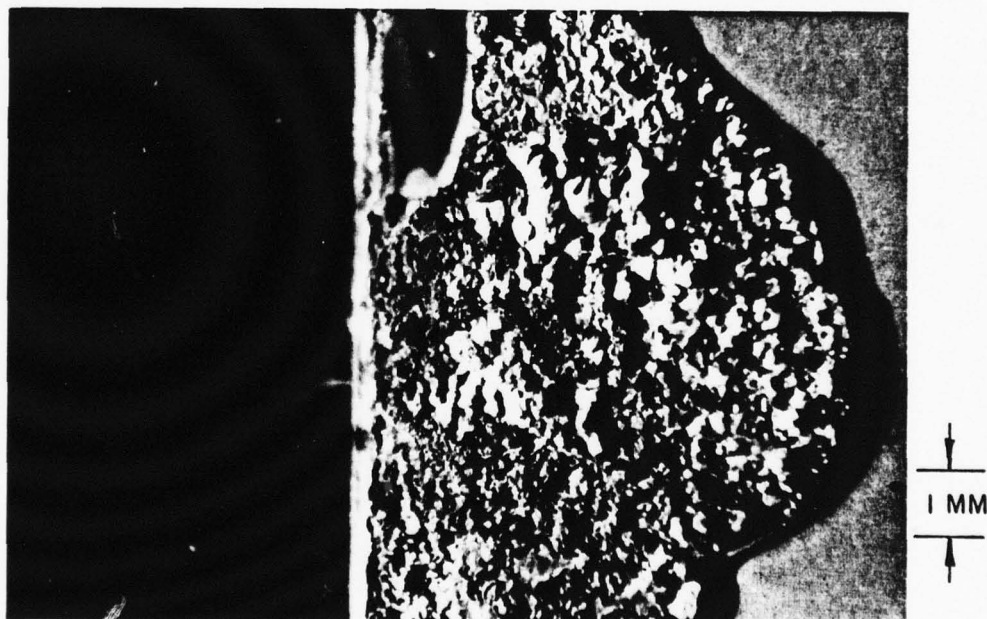
**Figure 7a - Close-Up of Coating Holiday After 898 Hours - Panel #1**

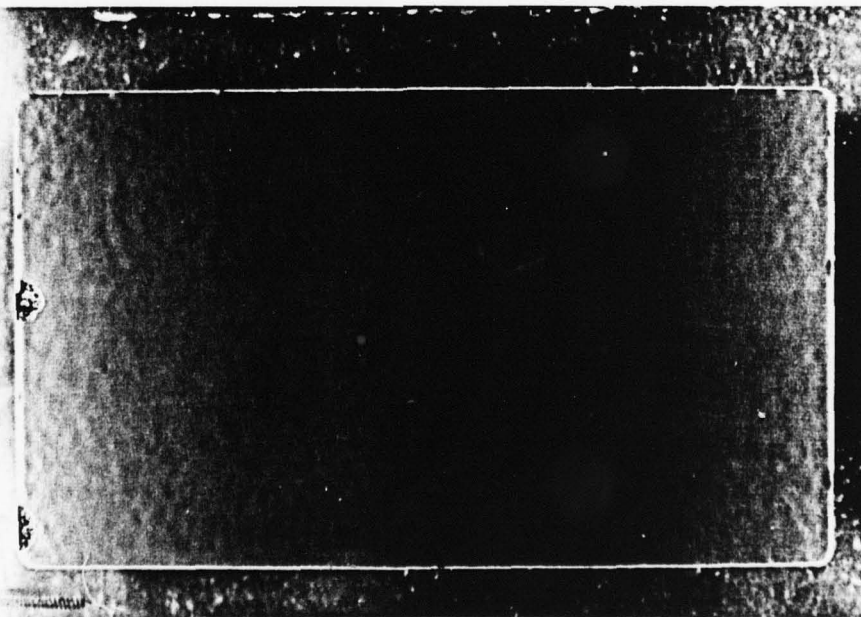
**Figure 9 - MIL-P-24441 Epoxy After 898 Hours Exposure to Seawater Flowing At  
30 m/s (Panel #1)**

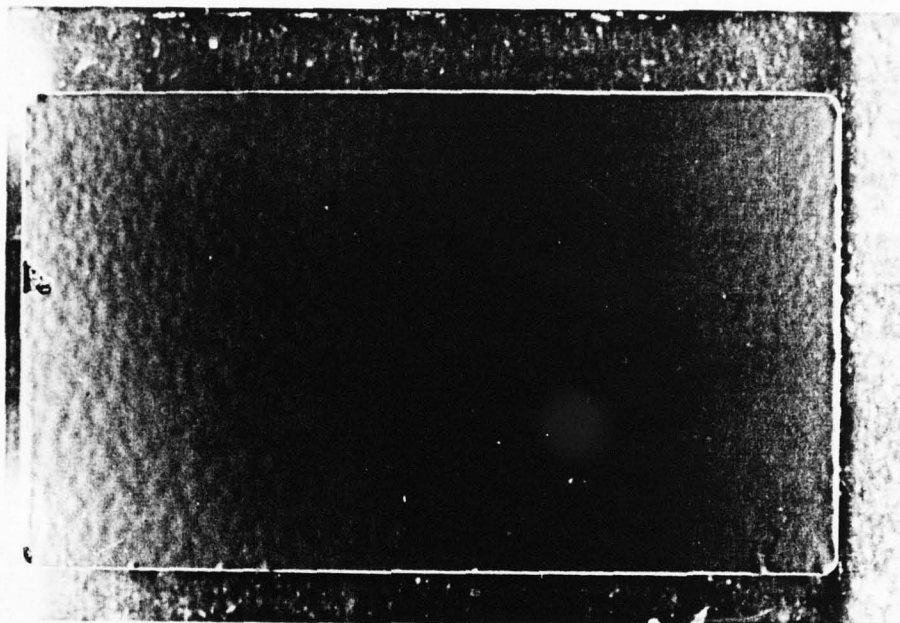
**Figure 10 - MIL-P-24441 Epoxy After 898 Hour Exposure to Seawater Flowing At 30 m/s (Panel #2)**

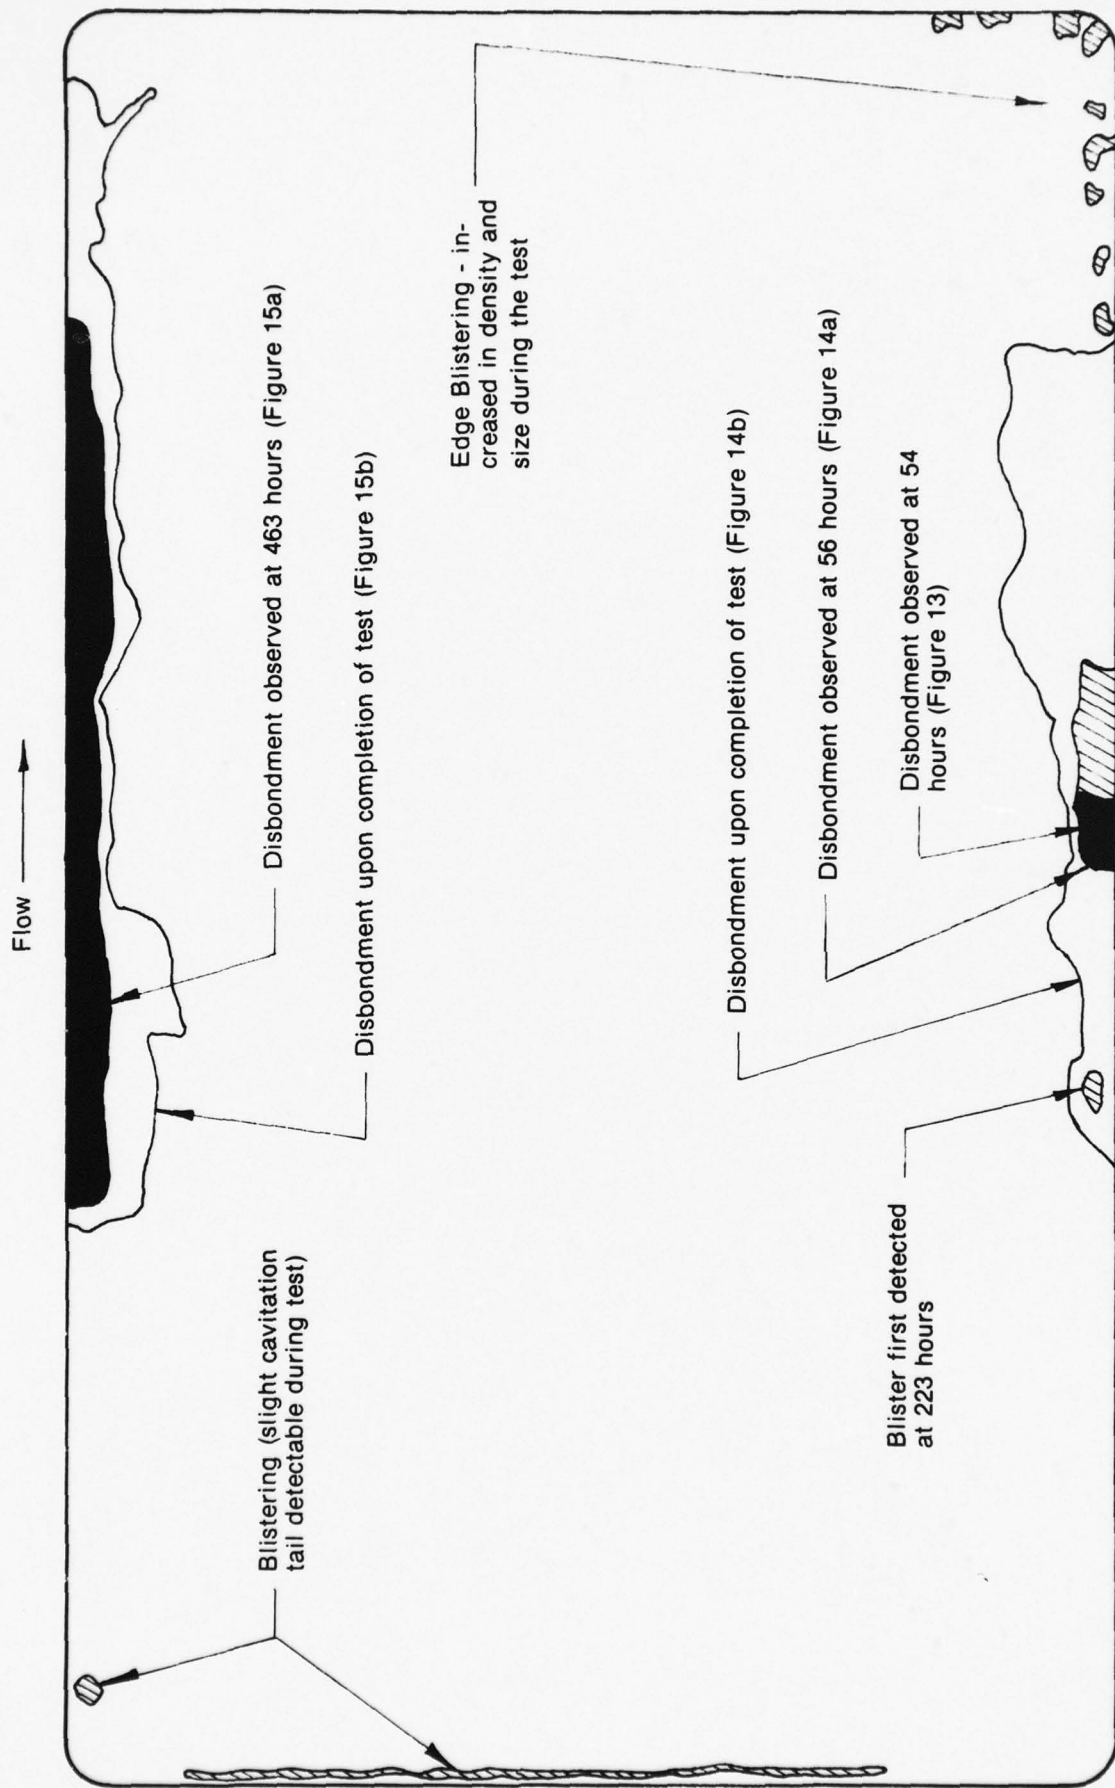
Figure 11 characterizes the deterioration observed on this coating over the test run. Figure 12 shows the test panel after 898 hours exposure. Failure of this coating system first occurred at 54 hours. The failure was in the form of disbondment along the bottom edge (Figure 13). The holiday did not remain stable over the test period, but continued to increase in size (Figure 14). Significant corrosion occurred on the exposed steel substrate. The maximum pit depth was .517 mm after 898 hours.

Figure 11 - Coating Failure Observed During Test Run at 30 m/s - Panel #3;  
DEVTRAN Epoxy (Approx. To Scale)

cavitation  
occurring at  
blister in  
coating

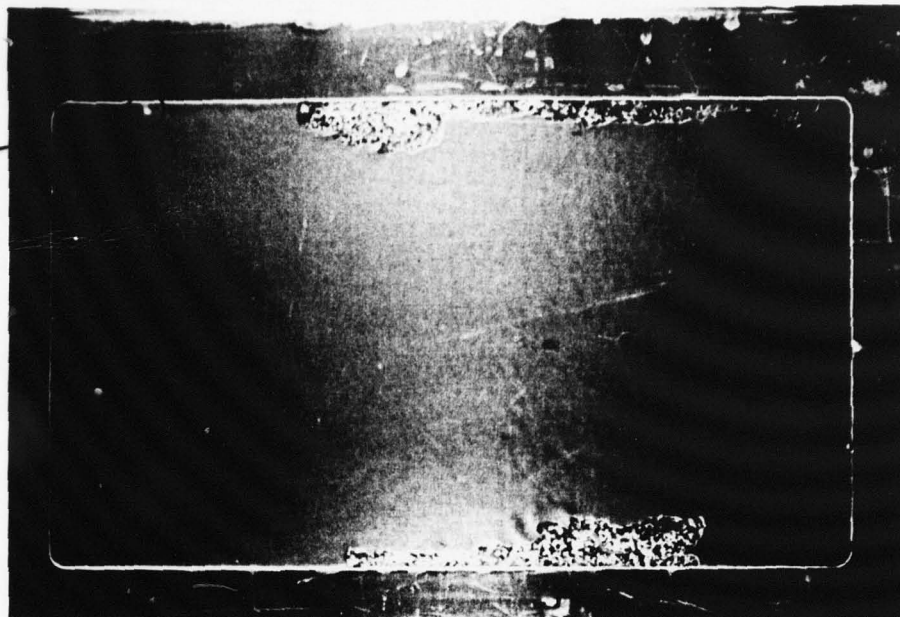
**Figure 12 - DEVRAN Epoxy At 898 Hours Exposure to Seawater Flowing At 30 m/s**

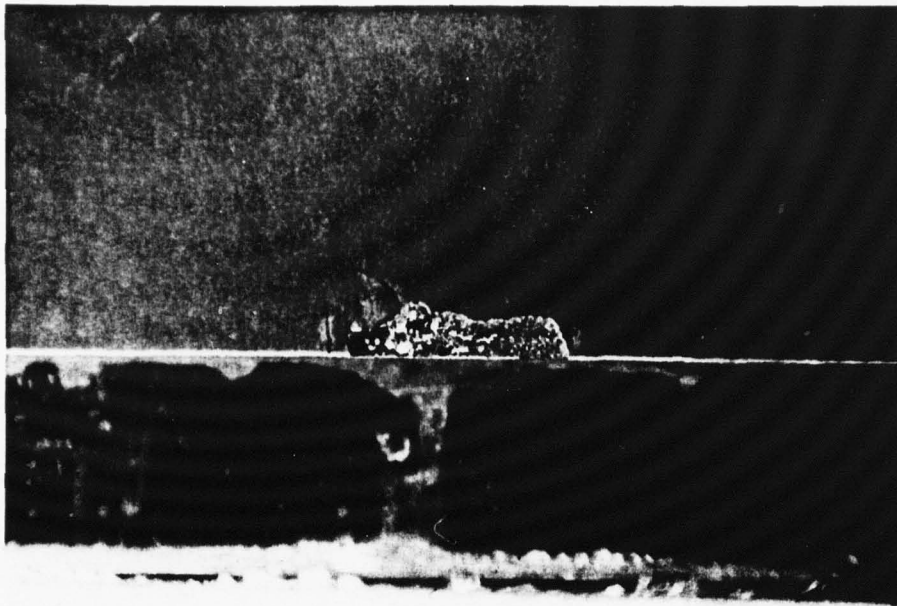
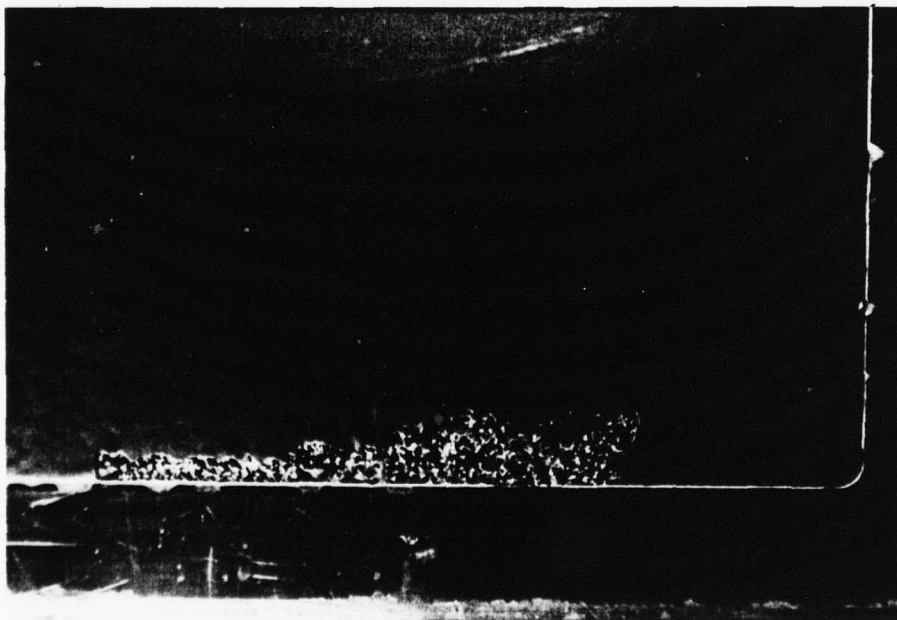
a. 56 Hours

b. 463 Hours

**Figure 14 - Development of Coating Holiday With Time - Panel #3; DEVTRAN Epoxy at 30 m/s (Lower Edge of Panel)**

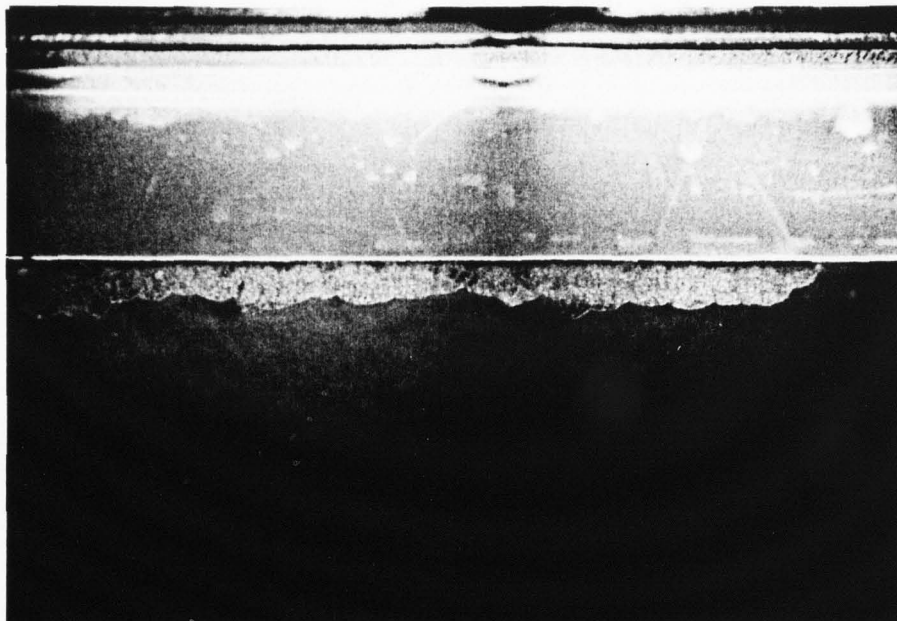
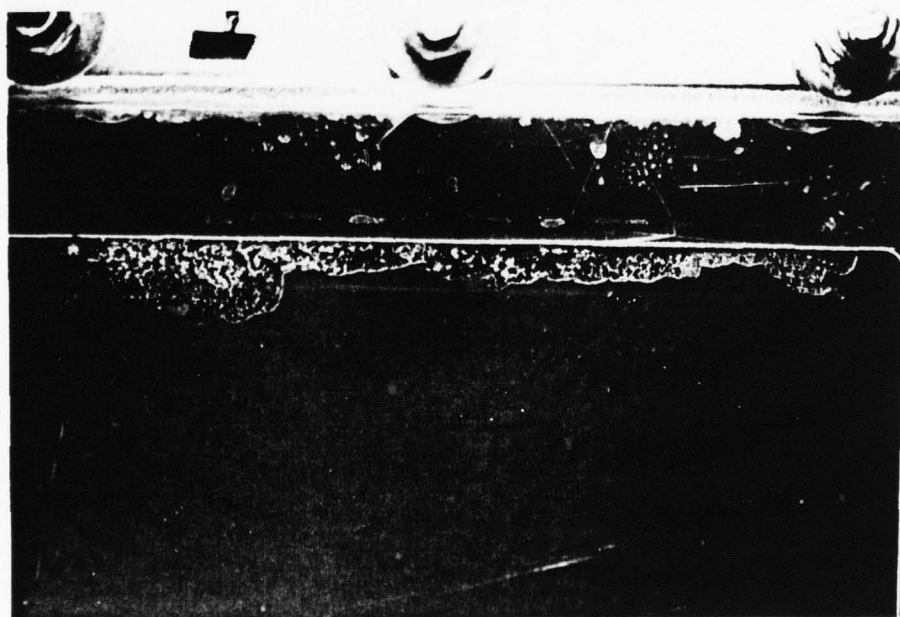
At about 460 hours into test, disbondment of the coating was observed on the upper edge of the test panel. This holiday also continued to increase in size over the rest of the test period (Figure 15). Final inspection of the test panel showed random blistering along the edges of the test panel. The DEVTRAN coating system suffered significantly more damage than the other coatings at 30 m/s.

a. 463 Hours

b. 898 Hours

Figure 15 - Development of Coating Holiday With Time - Panel #3; DEVRAN Epoxy at 30 m/s (Upper Edge of Panel)

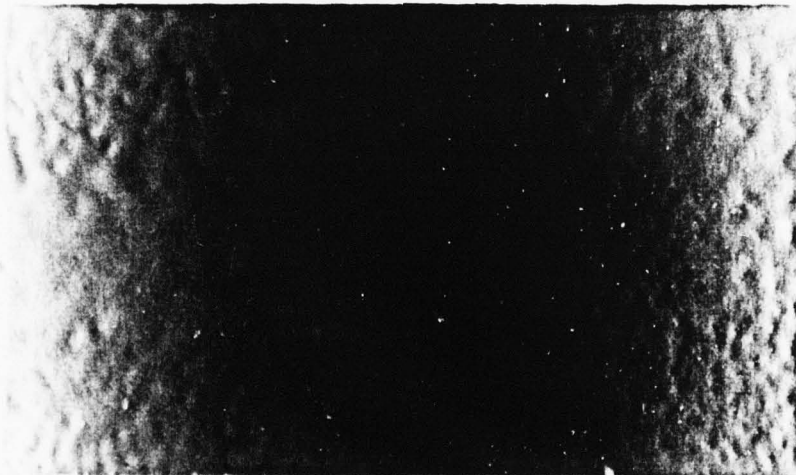
The one panel coated with coal tar-epoxy did not exhibit detectable deterioration over the 898 hour velocity test (Figure 16). Final inspection revealed slight blistering at a few isolated spots along the bottom edge. The coated panel showed no significant weight loss or measurable reduction in thickness.

**Figure 16 - Panel #4 TARSET Epoxy After 898 Hours Exposure to Seawater  
Flowing At 30 m/s**

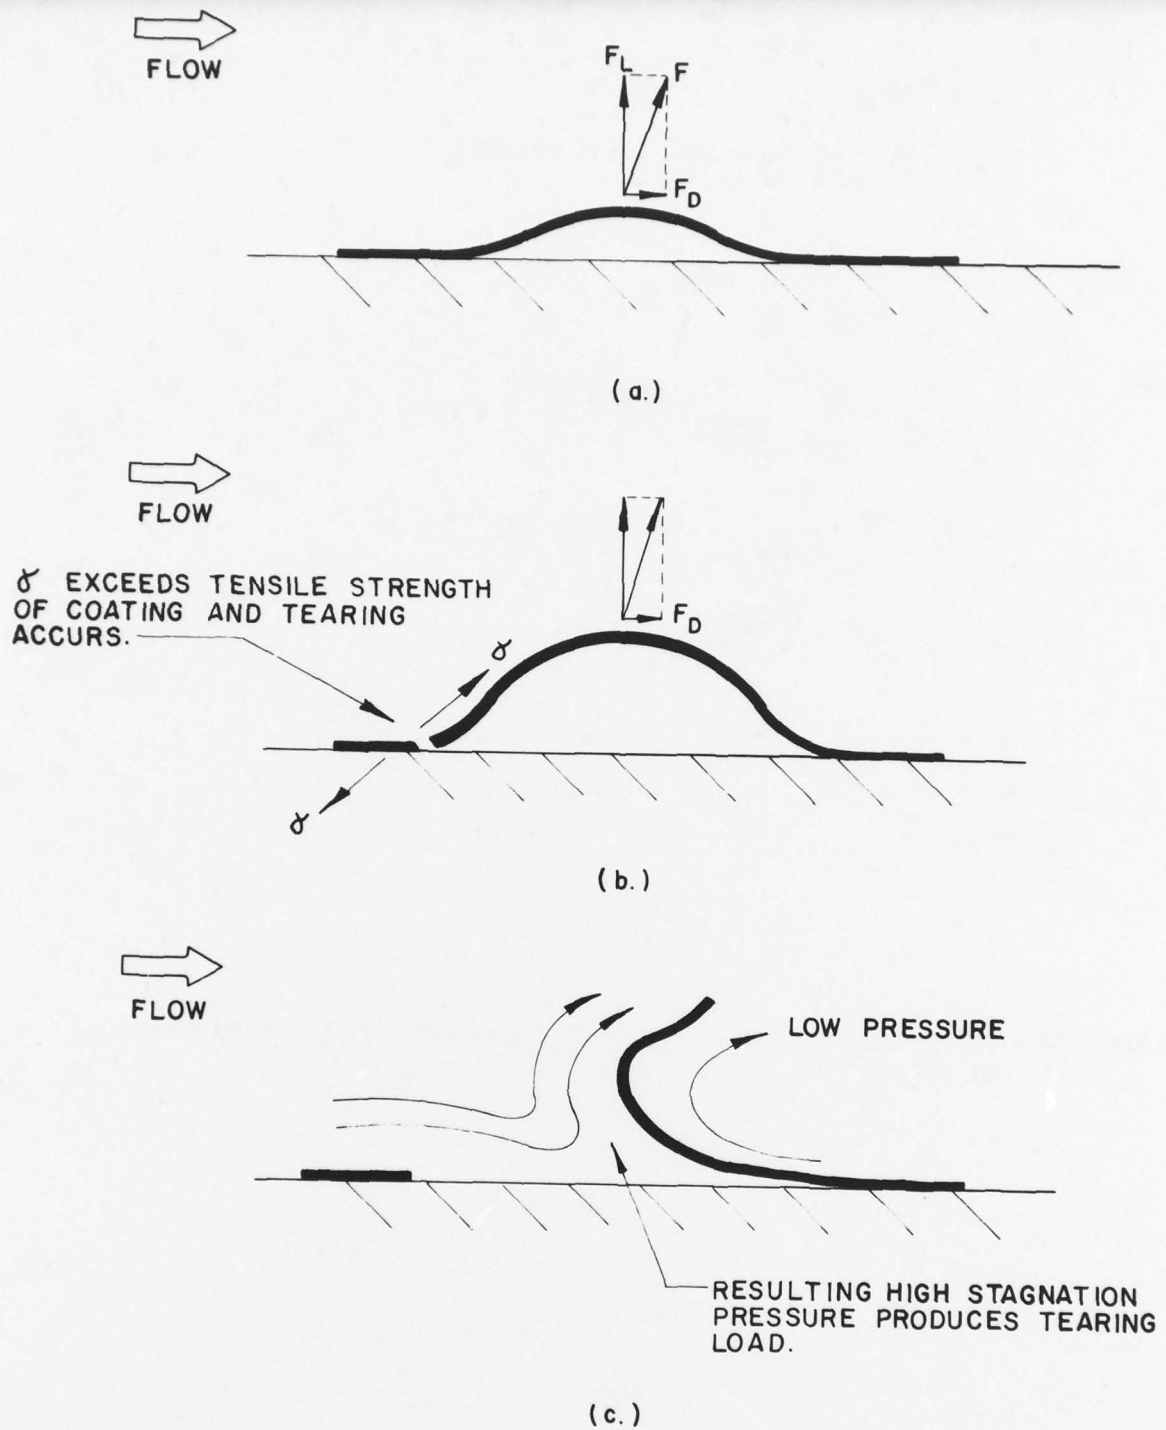
FIGURE 31 - POSSIBLE COATING FAILURE MECHANISM AT HIGH VELOCITY.

In general conformance with Hackworth's proposed failure mode, Figure 31 presents a simplified picture of the forces that might arise about a blister and how the coating might ultimately respond to such forces. As shown, two mutually perpendicular forces — lift and pressure drag — are distributed over the surface of the blister. The pertinent equations from airfoil theory describing these forces are as follows:

A lifting force would create a differential pressure across the coating at the point of the blister. The situation would be somewhat analogous to the action of a plumber's helper (suction-type plunger). As the coating is lifted from the substrate, it would tend to create a vacuum in the area between the coating and substrate. The resulting differential pressure would accelerate seawater transport through the coating at the blister. The additional volume of seawater entering the blister would increase corrosion of the substrate leading to further breakdown of the adhesive bond and increase expansion stresses from corrosion product formation. Under the combined action of these forces, the blister would continue to grow. Ultimately, the blister reaches a critical size such that the hydrodynamic forces are resolved causing a tensile stress in the coating that exceeds its inherent tensile strength and gross rupture occurs.

LIMIT OF COATING DISBONDMENT  
BENEATH BLISTER.
